IRRIGATION REPAIR REPORT

By Frank Shafer

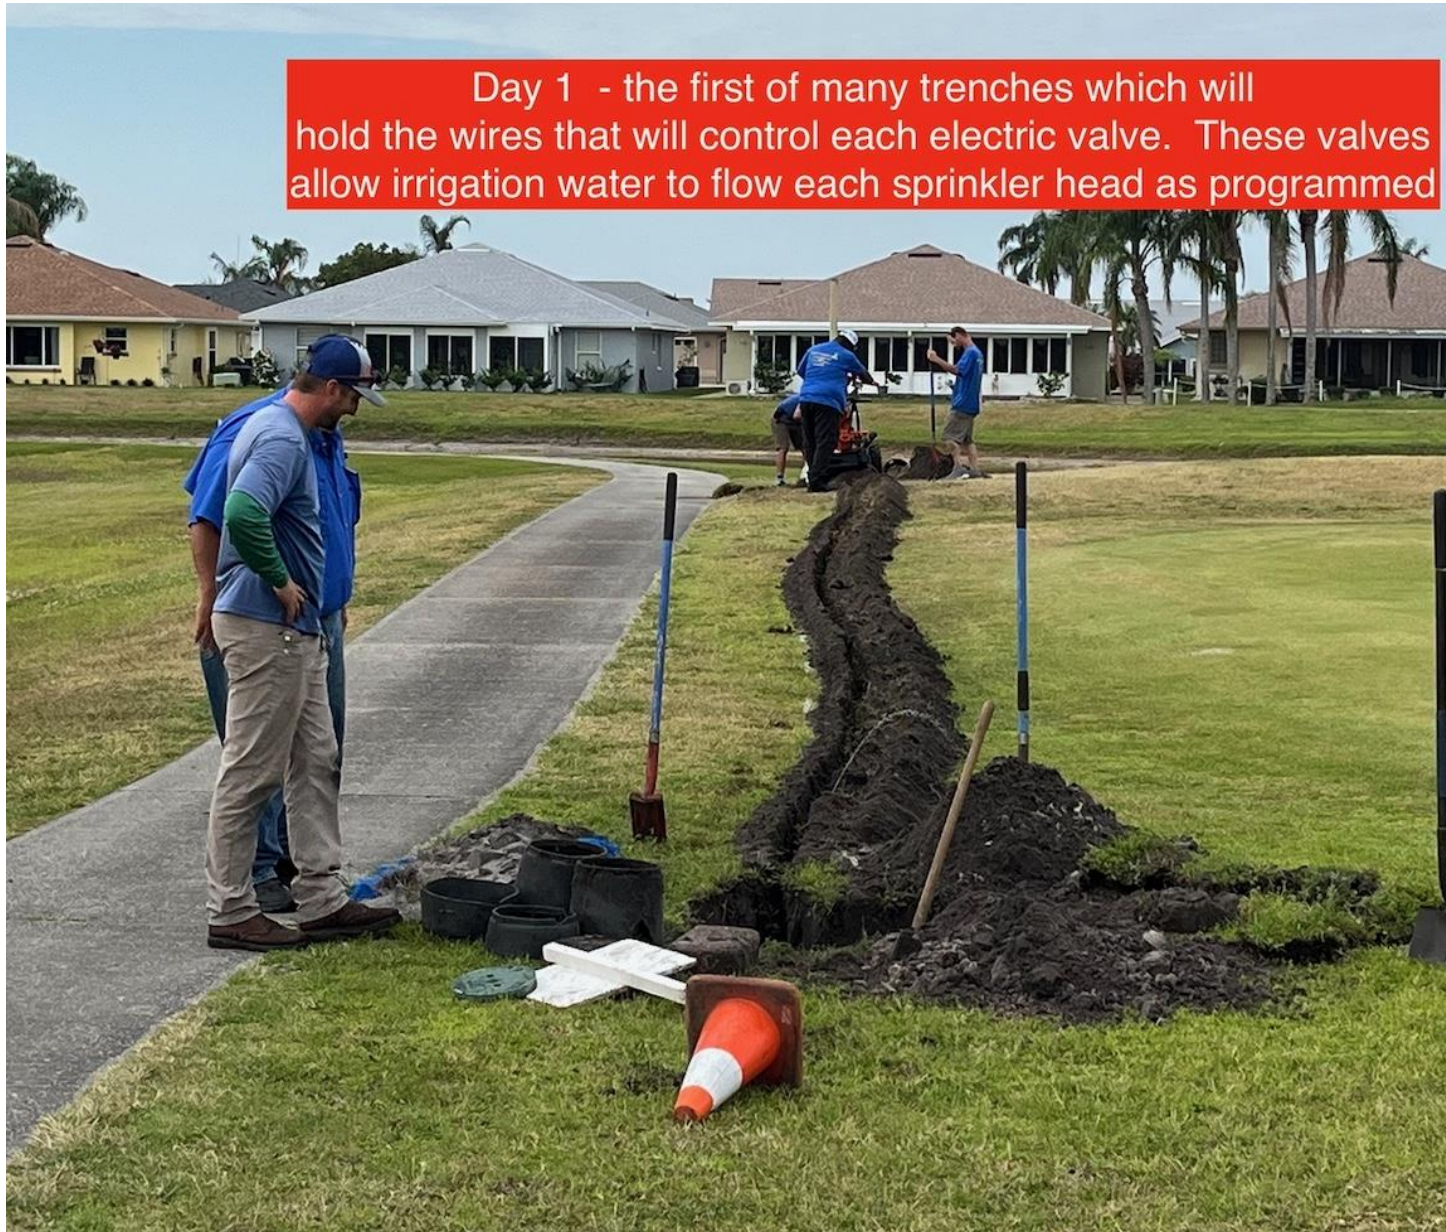
Old water controlled valves

These 1/4 inch water lines open and close the valves

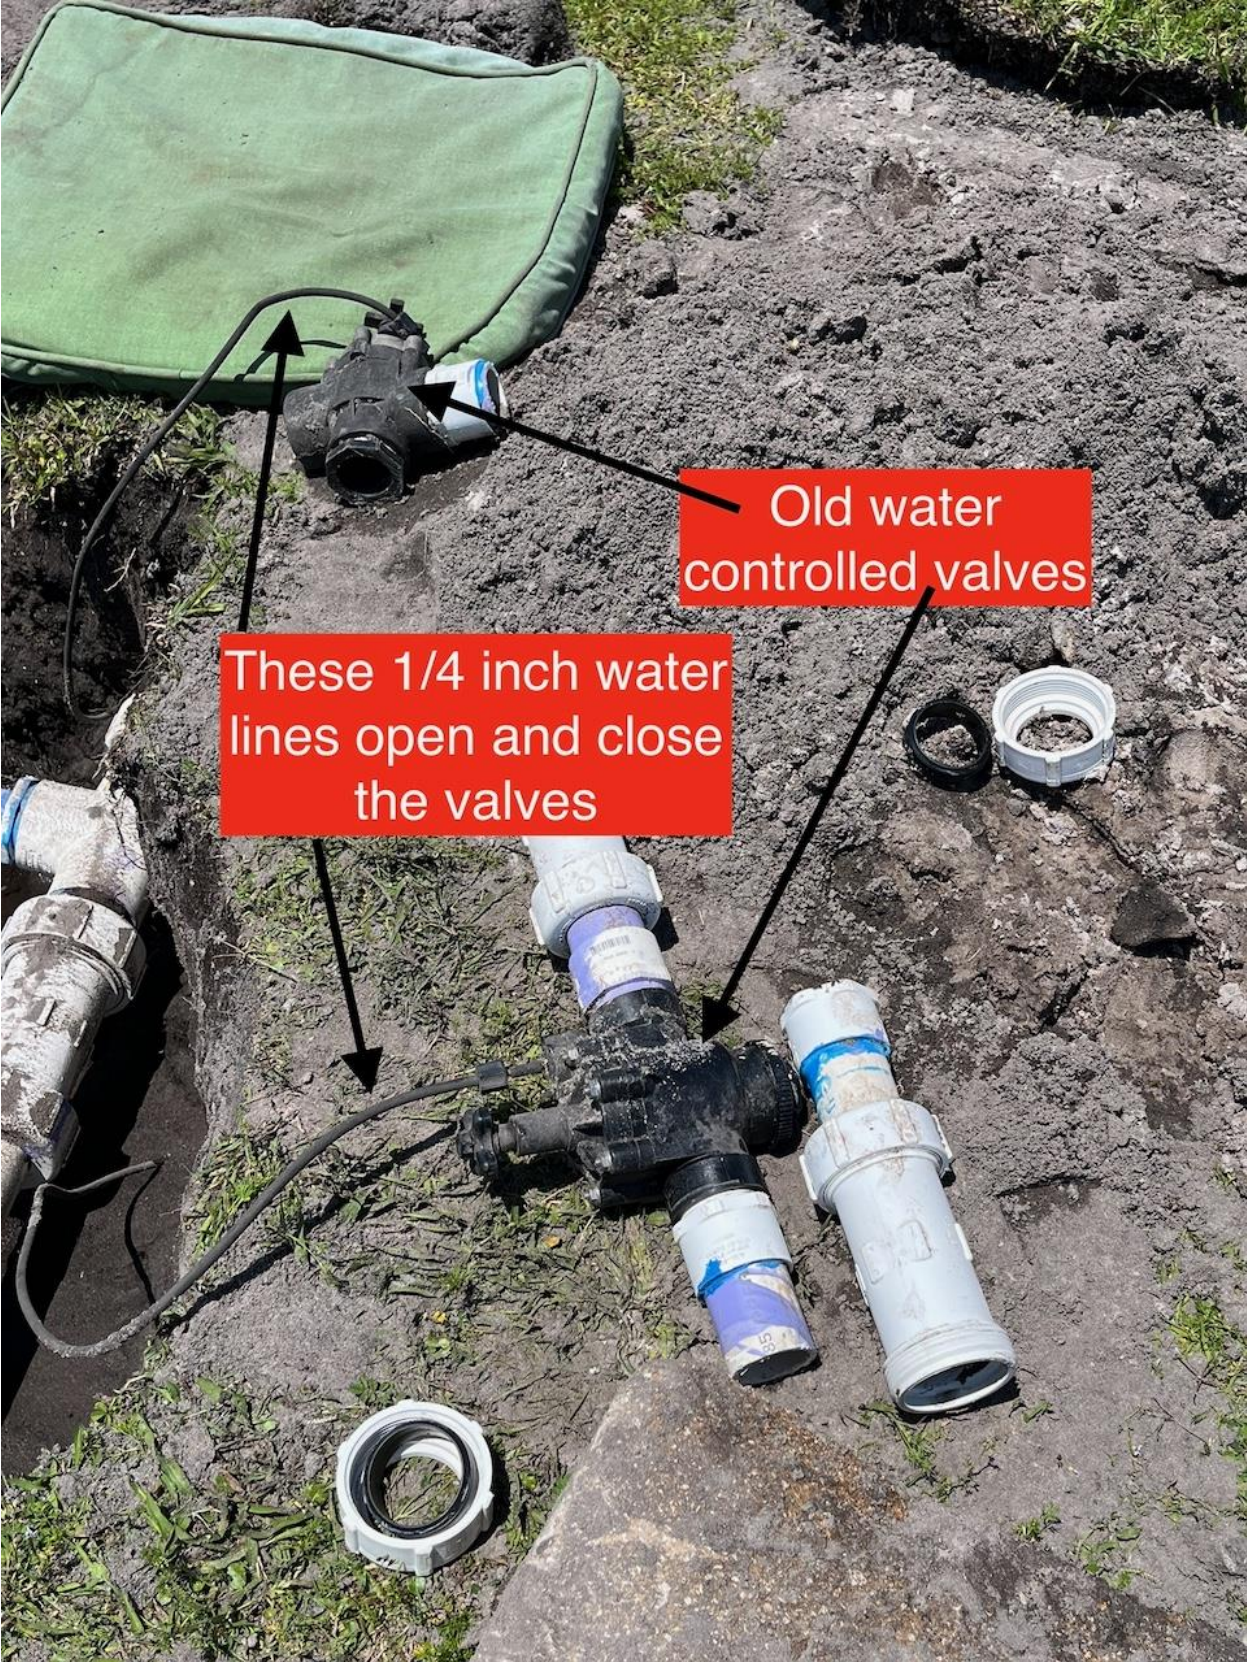
Frog

Backside of control box where each control valve water line ties in

Green solenoids where pins are located

In-line water filter for control valves

Some of you may have also noticed that there is water at the base of many of our Control boxes. This is because there are leaks in some of the connections of the quarter of an inch line to the back panel of the Control Box. These moist areas are attractive places for things like frogs and snakes to live. This makes for an interesting moment when we first take off the back and front covers of the Control Box as to see who's living there.

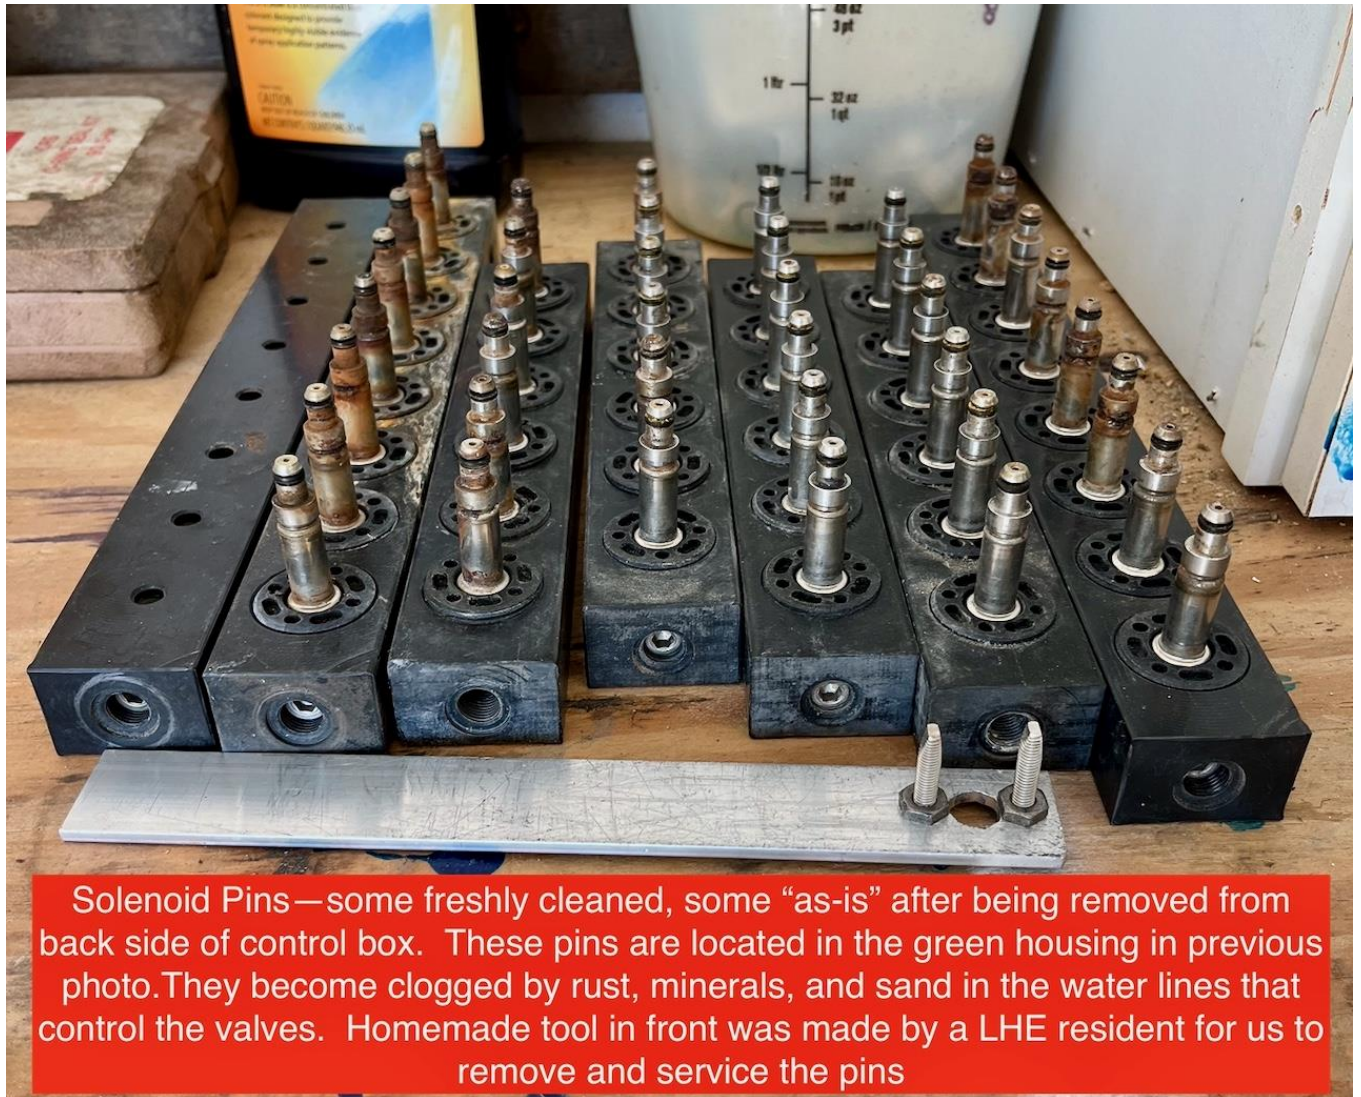
Solenoid Pins—some freshly cleaned, some “as-is” after being removed from back side of control box. These pins are located in the green housing in previous photo. They become clogged by rust, minerals, and sand in the water lines that control the valves. Homemade tool in front was made by a LHE resident for us to remove and service the pins

In the photo of the Solenoid Pins, the tip of the pin has a hole where the water is sent to a valve via the one-quarter inch water line. You can see how small that hole is and how something as small as a few grains of sand can impede the water flow.

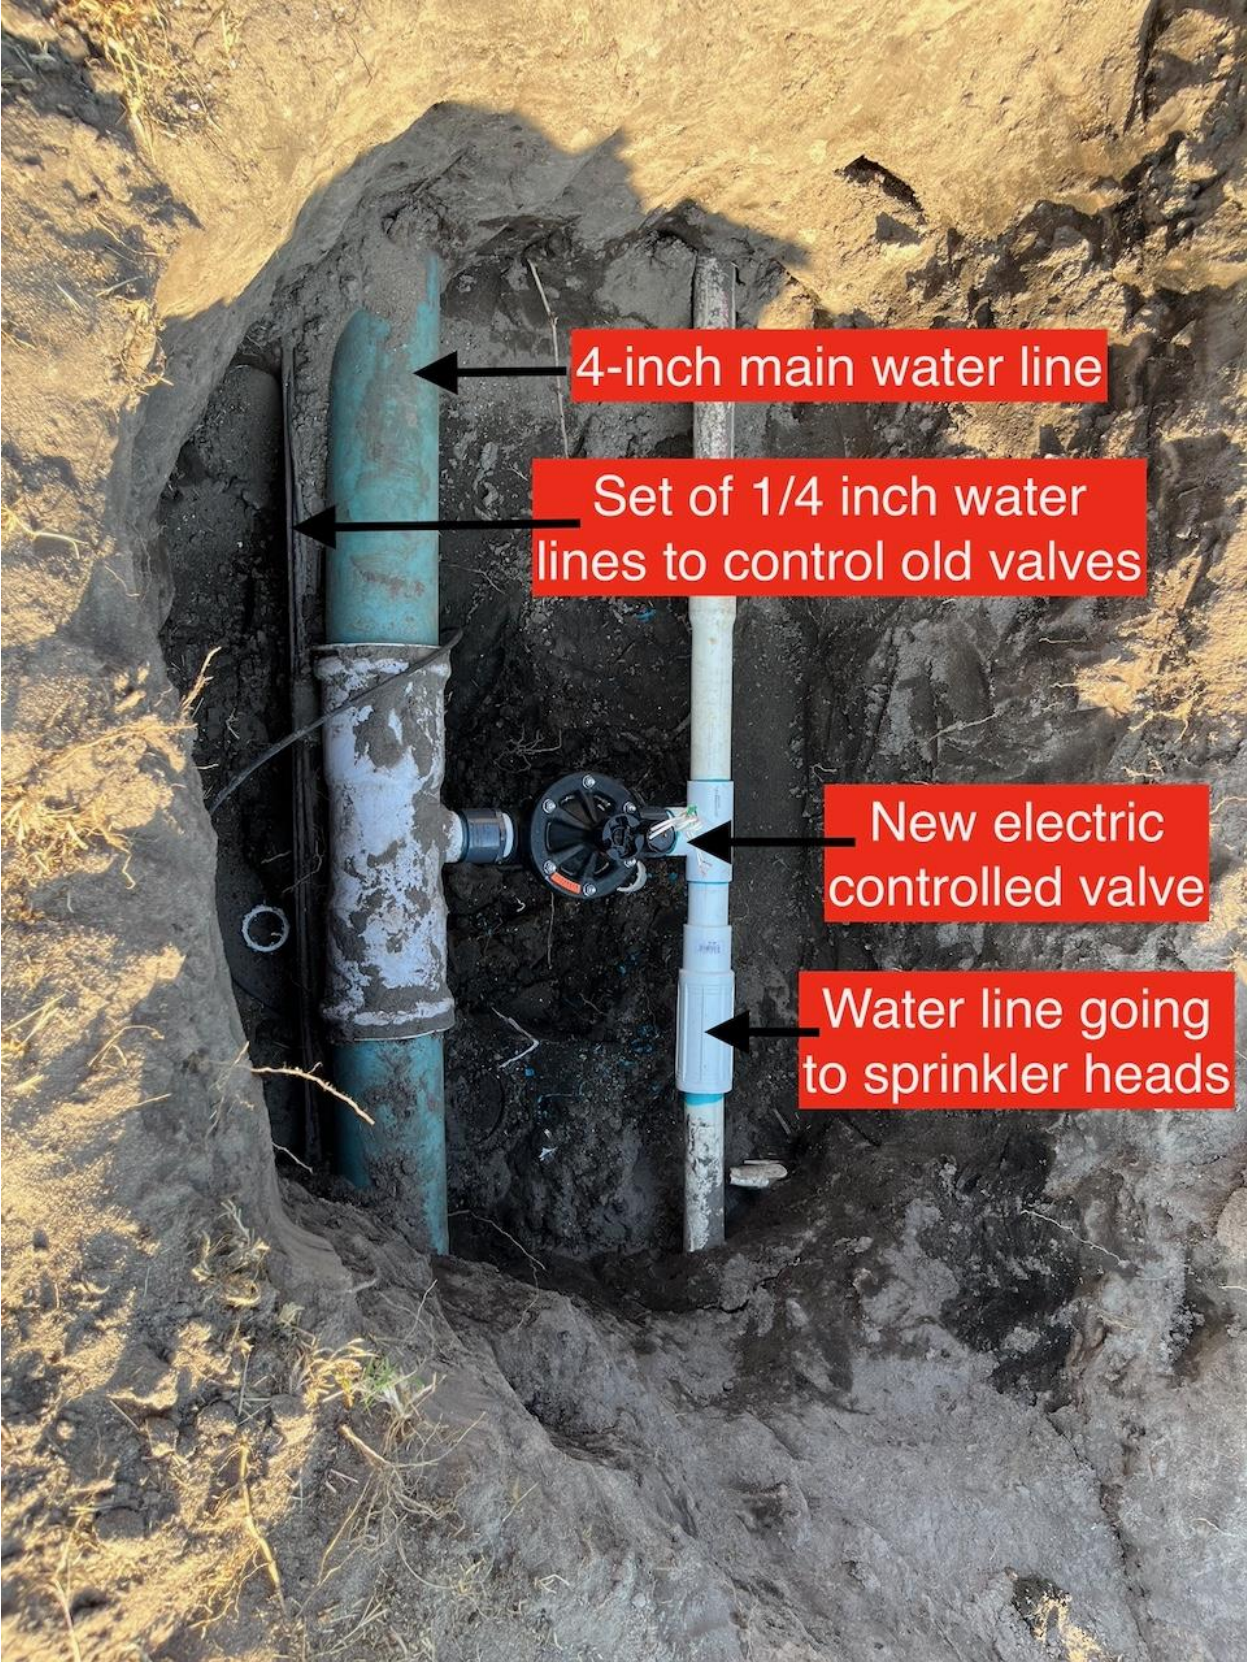
4-inch main water line

Set of 1/4 inch water lines to control old valves

New electric controlled valve

Water line going to sprinkler heads

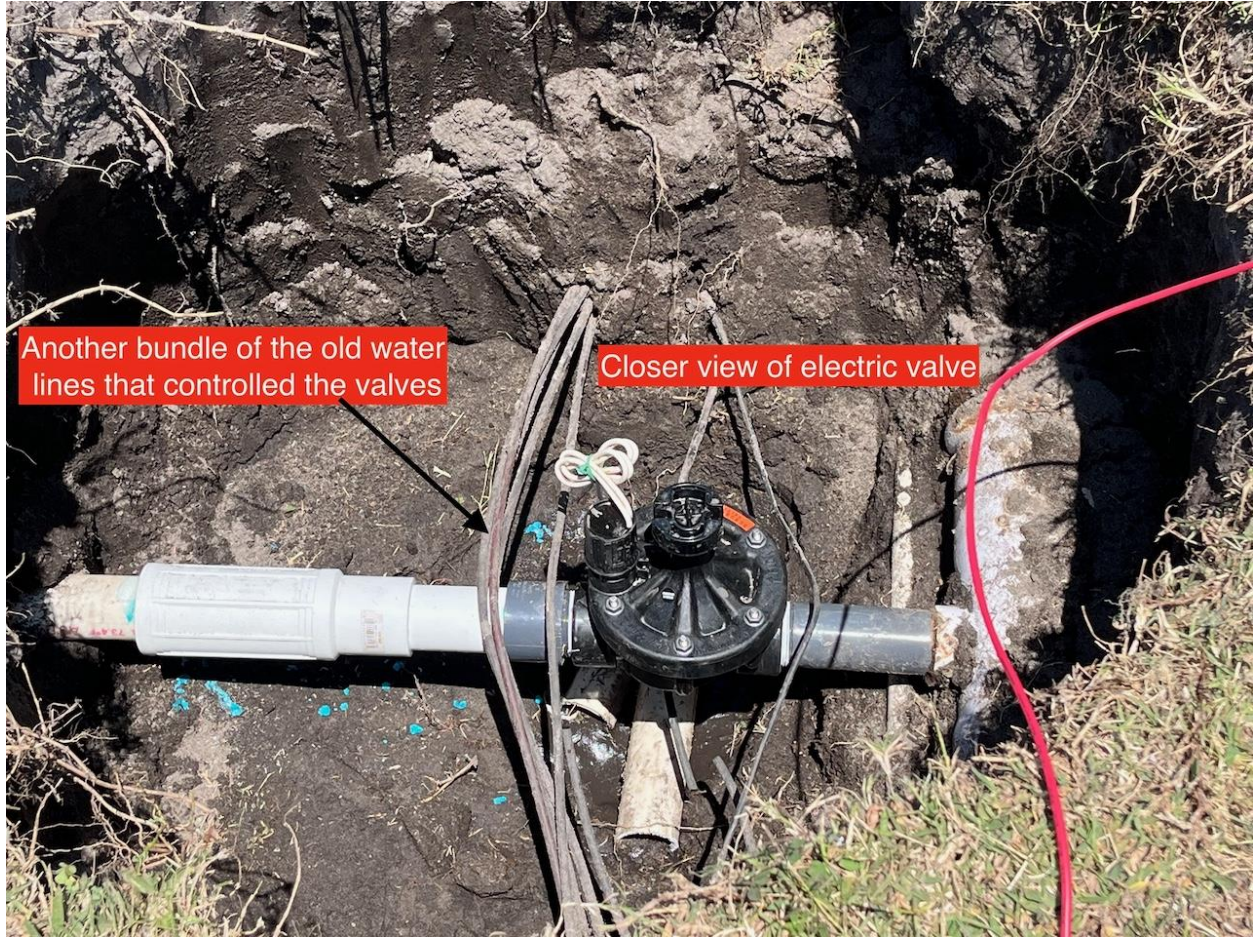
Another bundle of the old water lines that controlled the valves

Closer view of electric valve

Two electric water valves
with wiring attached

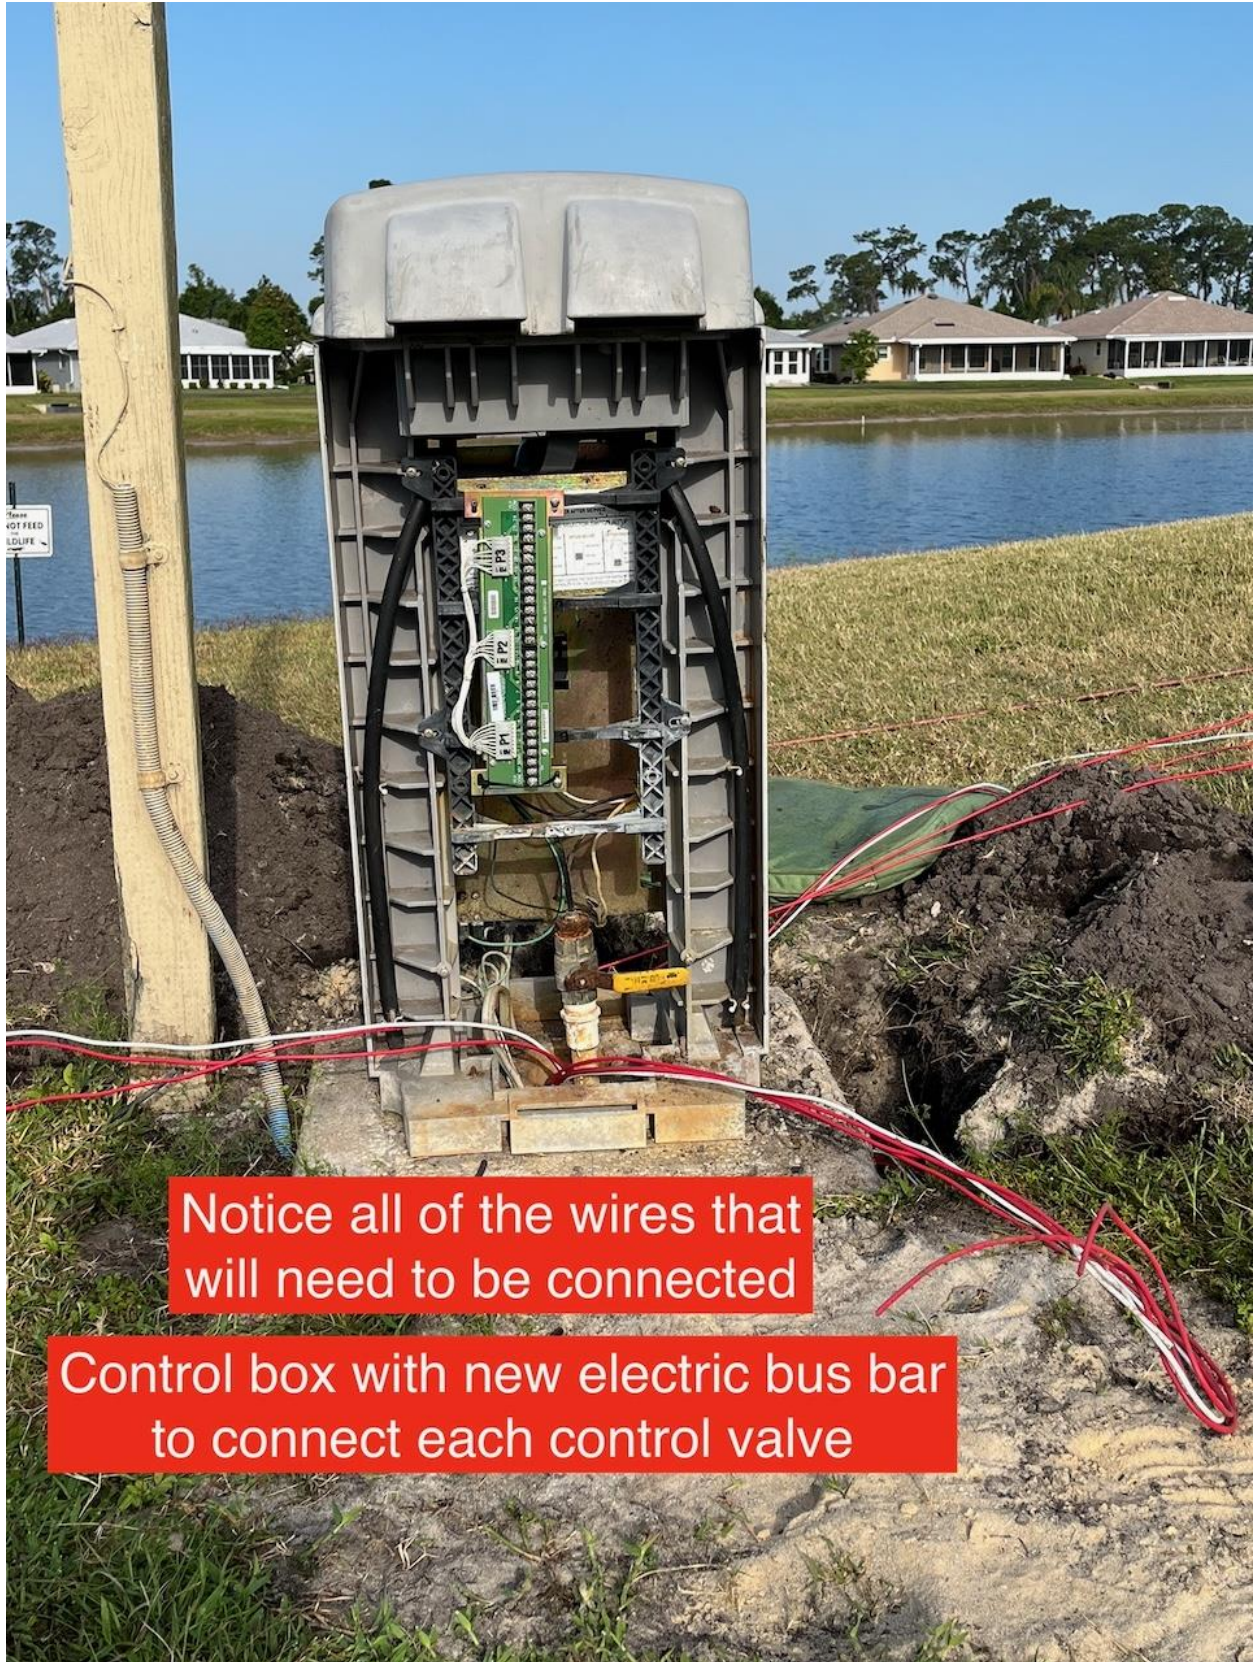
Notice all of the wires that will need to be connected

Control box with new electric bus bar to connect each control valve

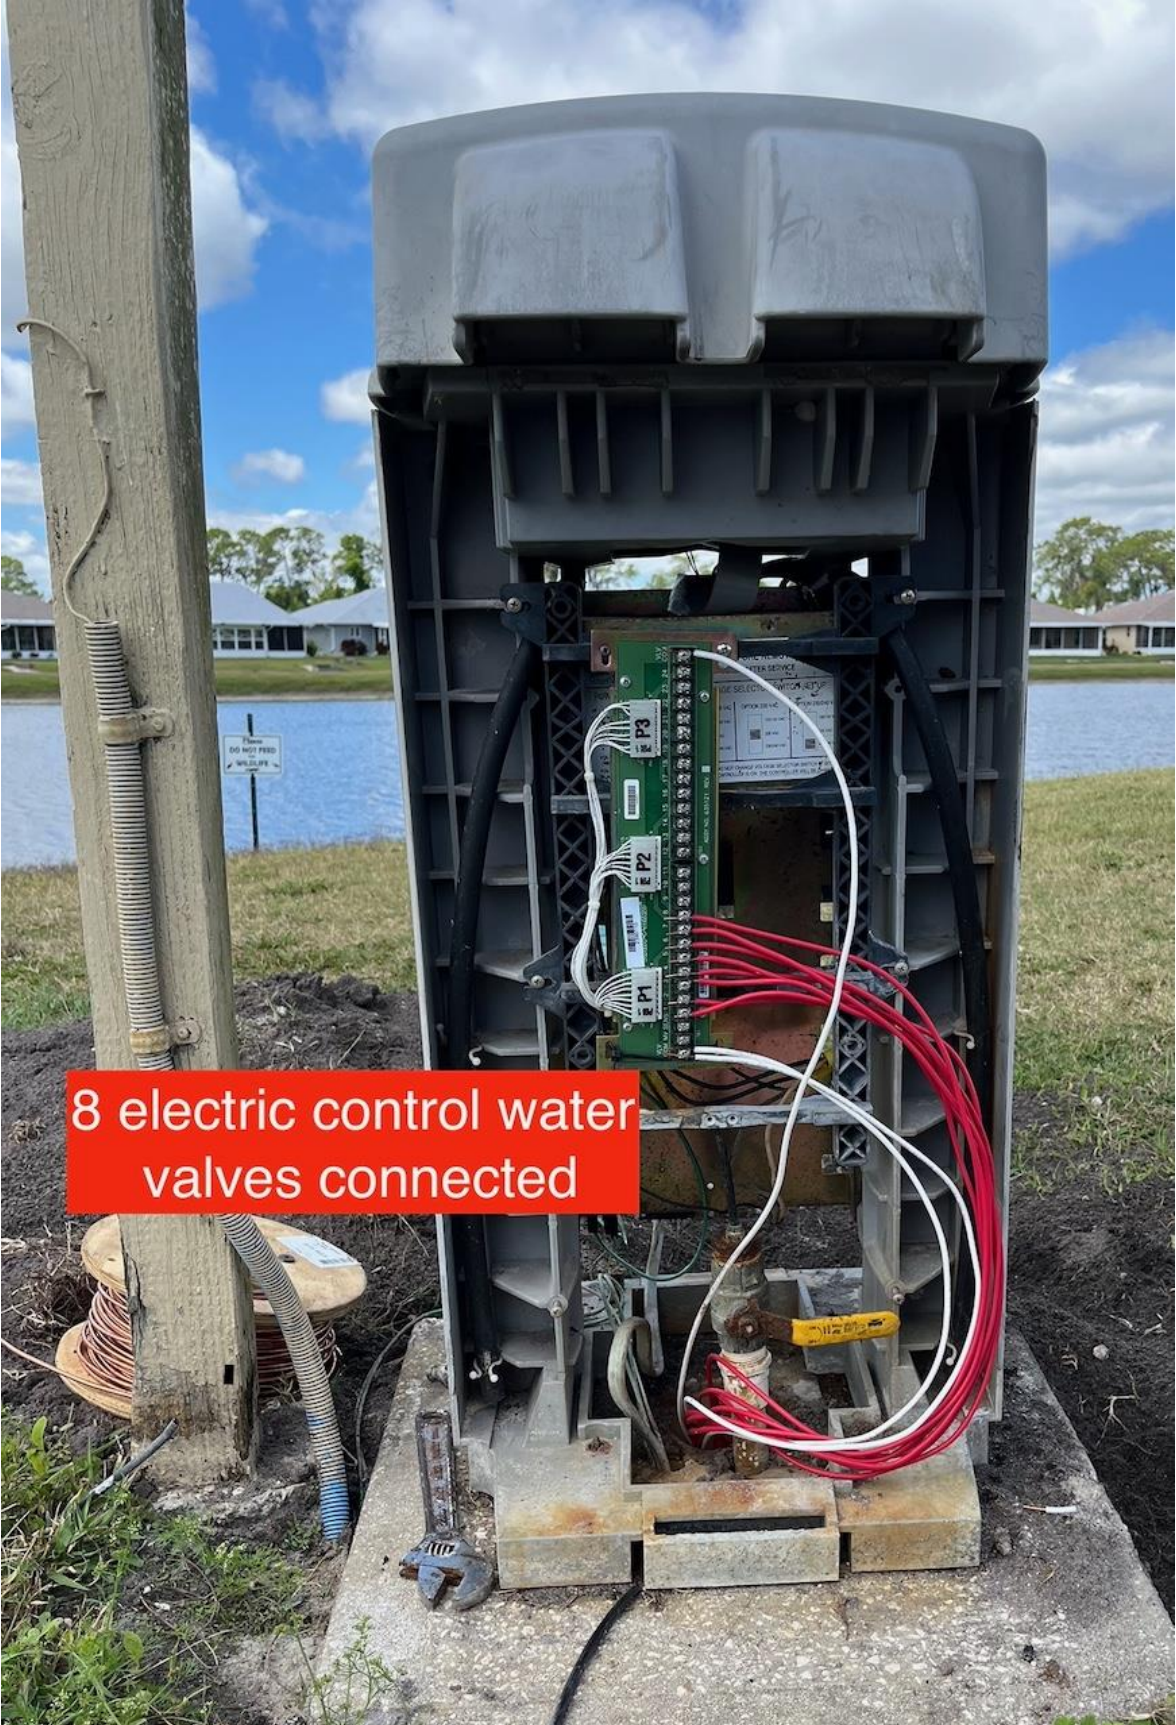
8 electric control water valves connected

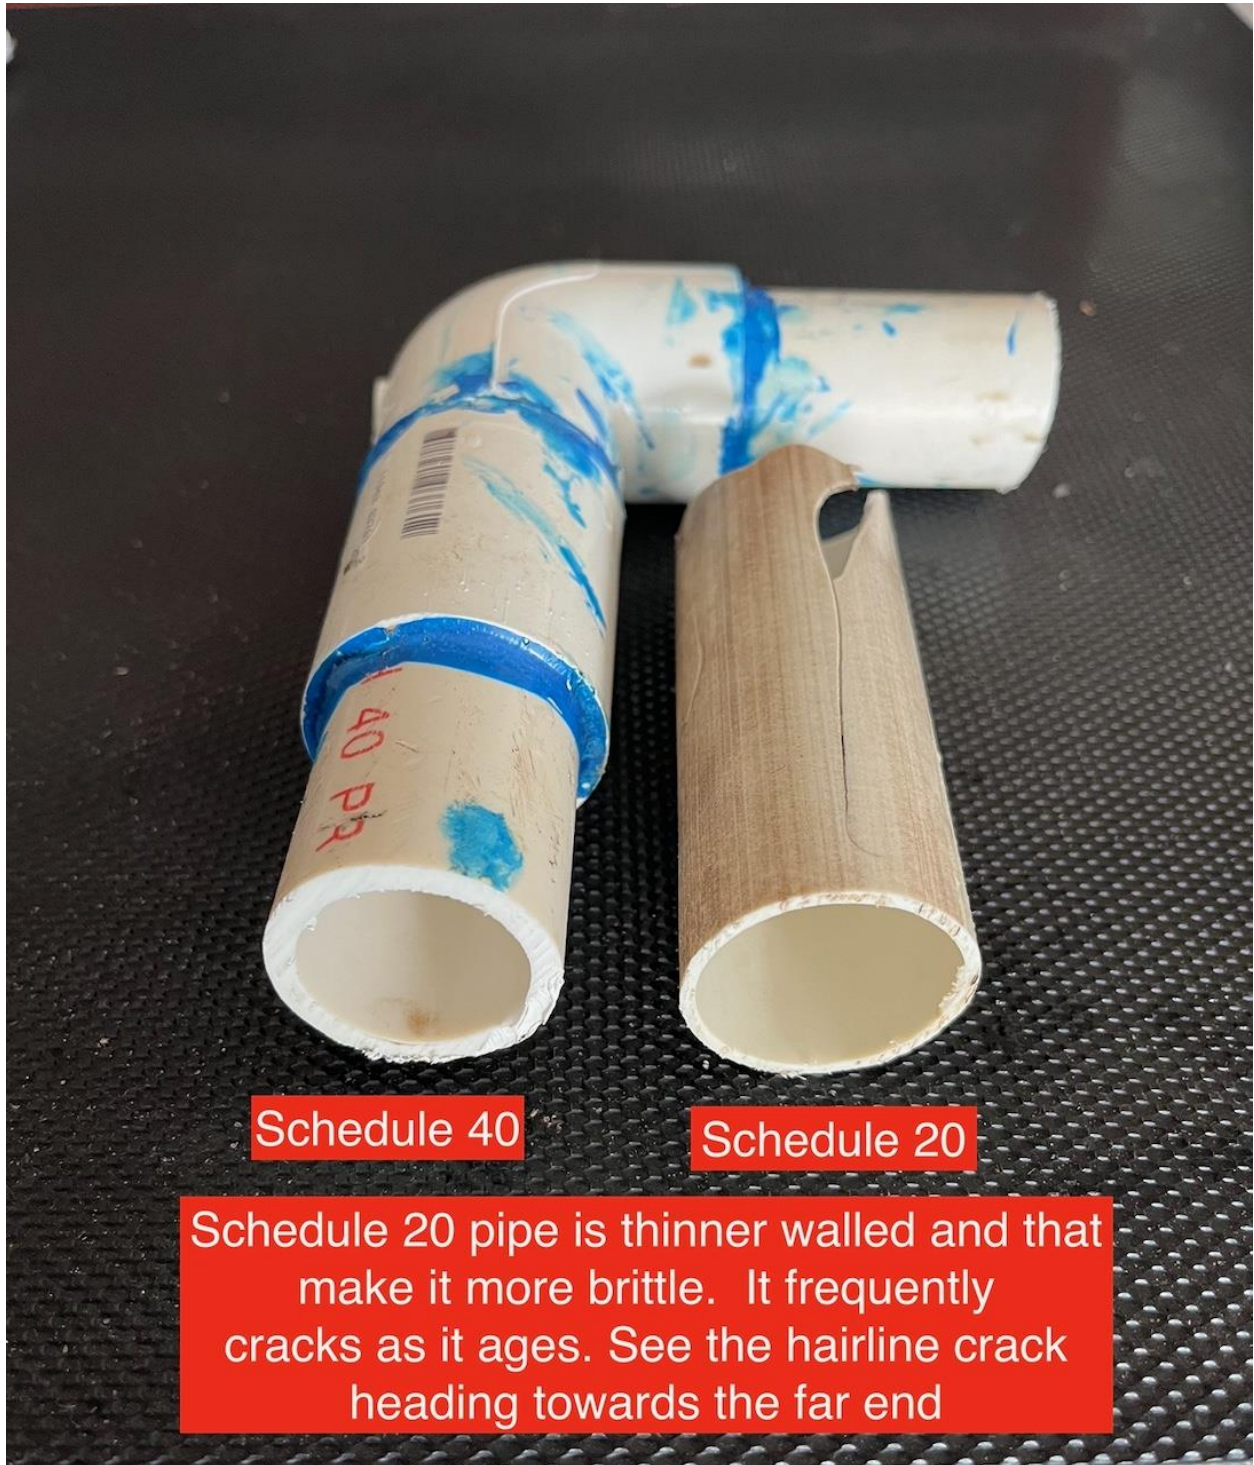
Schedule 40

Schedule 20

Schedule 20 pipe is thinner walled and that make it more brittle. It frequently cracks as it ages. See the hairline crack heading towards the far end

I've also included some photos on the piping that is used on the golf course. Unfortunately, a lower quality pipe was used in sections. We don't know where this lower quality pipe is located until a leak develops. We then have to excavate along the broken or cracked pipe some distance to find where it connects to the higher quality pipe in order to make a proper repair.

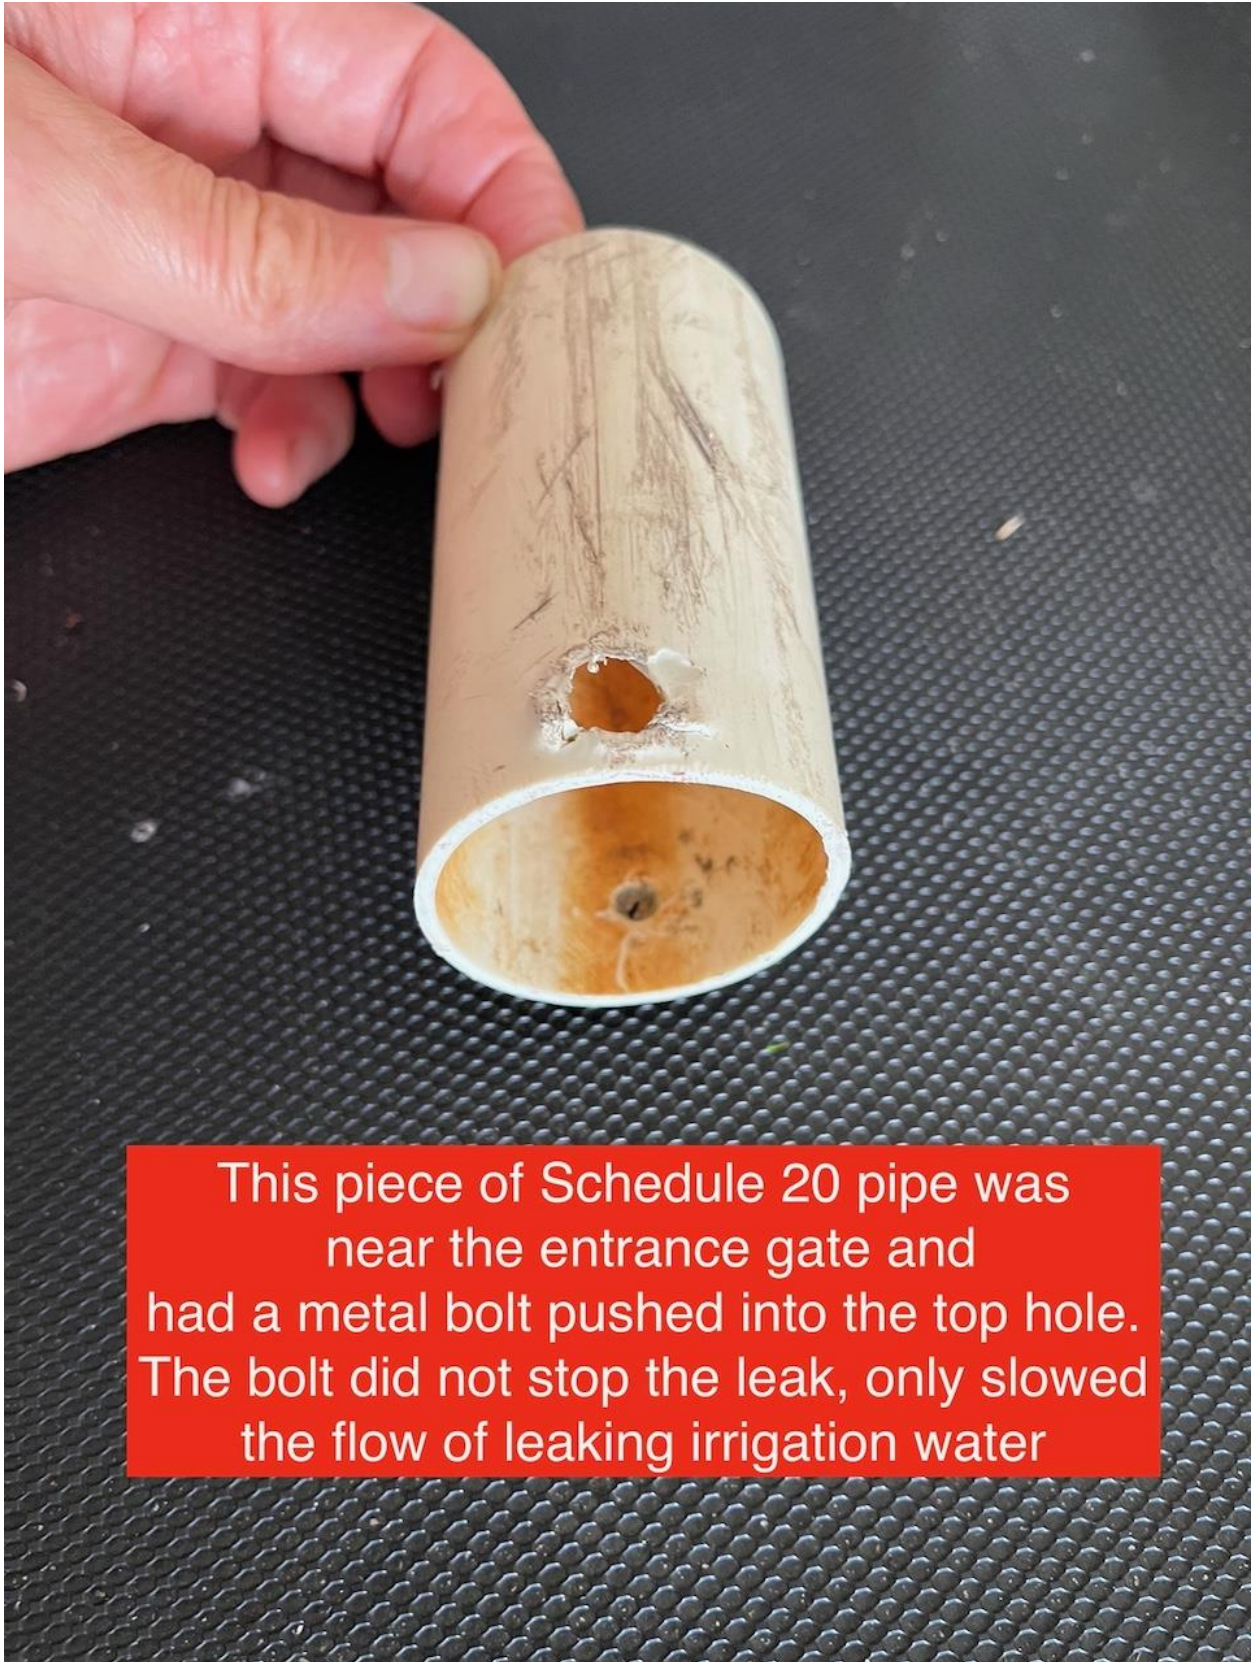
This piece of Schedule 20 pipe was near the entrance gate and had a metal bolt pushed into the top hole. The bolt did not stop the leak, only slowed the flow of leaking irrigation water

Another piece of Schedule 20 pipe by Tee Box 5

Hole created by busted pipe

Cracks nearly all the way to the end
